Understanding Rotator Cuff Tears and Repairs

by **Kevin Michael Kaplan, MD**
Sports Medicine, Joint Replacement
SAN MARCO

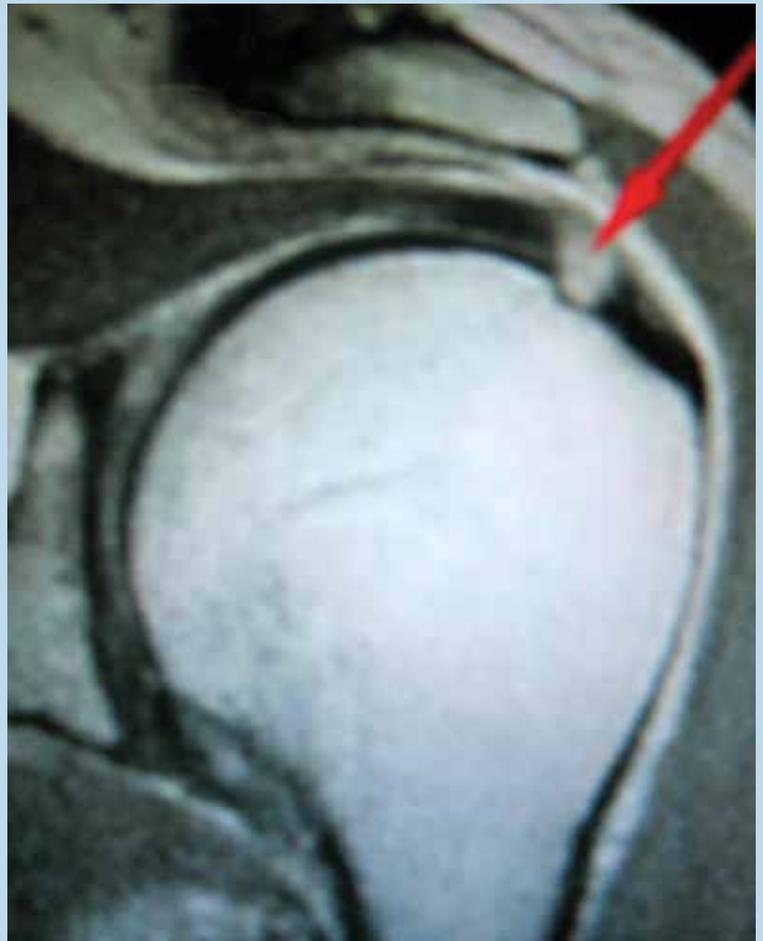
Figure 1: MRI demonstrating a rotator cuff tear. The arrow points to a gap in the tendon, indicative of a tear.

Diagnosis of a rotator cuff tear can be made with a combination of history, physical exam, and radiographic studies. By thoroughly examining patients with shoulder pain and tests specific to this type of injury, patients may be sent for a confirmatory test such as a magnetic resonance imaging (MRI). This imaging modality is the test of choice to evaluate for a rotator cuff tear (Figure 1).

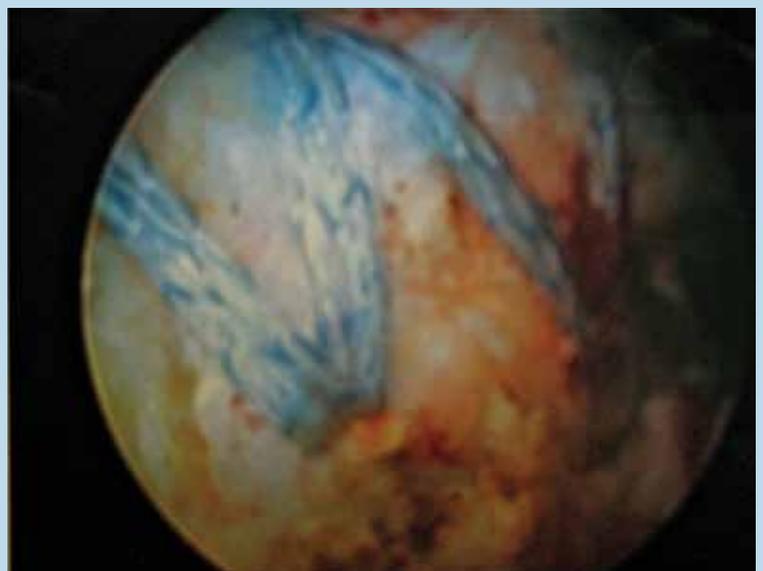
Figure 2: The NET Bridge utilizes several specially designed sutures including the above shown fibertape, in a novel configuration to achieve the strongest and most durable repair.

In a soon to be published article in the orthopaedic surgery literature, I describe a technique (The NET bridge designed by Dr. Neal ElAttrache) that I tested in a biomechanics laboratory and found it to be the strongest rotator cuff repair reported to date. The NET bridge utilizes a combination of high strength suture materials in a novel configuration to achieve the maximal strength of repair while also maximizing the contact between the torn tendon and bone of the humerus (Figure 2). One of the biggest pitfalls with rotator cuff surgery is avoiding a re-tear of the tendon. However, a common complication that can also be a considerable challenge is post-operative stiffness. By providing a stronger, more durable repair in utilizing the NET bridge, my patients can expect an early return to their daily activities through range of motion exercises and shorter time in a sling.
